Manhole Inspection Summary

Manhole # S17G__054MH

Insp Date: **1/24/09 9:41 AM**

Location Address: **101 N WARWICK AVE**

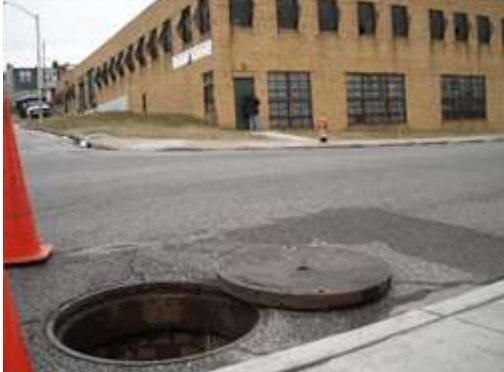
Location View

N WARWICK AND W FAYETTE ST

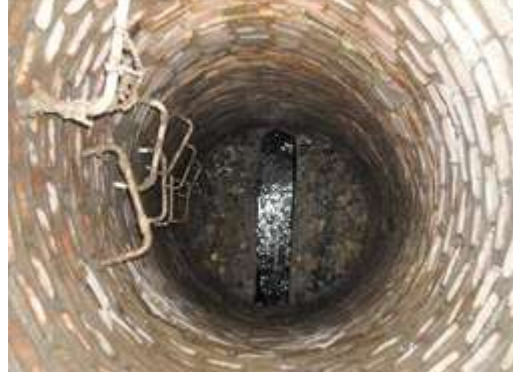
Top View

SHEETING

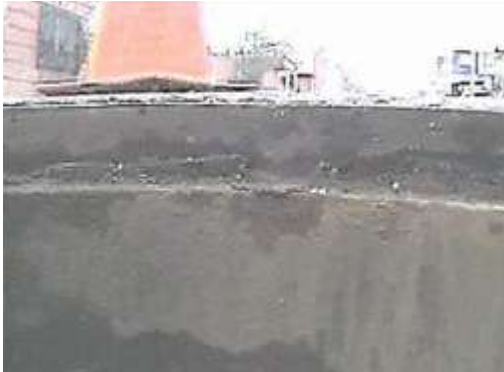
Defect 1

EVIDENCE OF INFLOW DUE TO SHEETING OFF CROWN OF ROADWAY

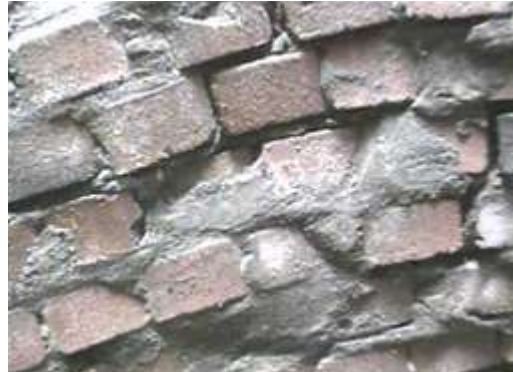
Defect 2

Condition: ☐ Sound ☒ **Cracked** ☐ Root Intrusion ☐ Loose Brick ☒ **Deteriorated**

DEFORMATION IN BARREL WALL

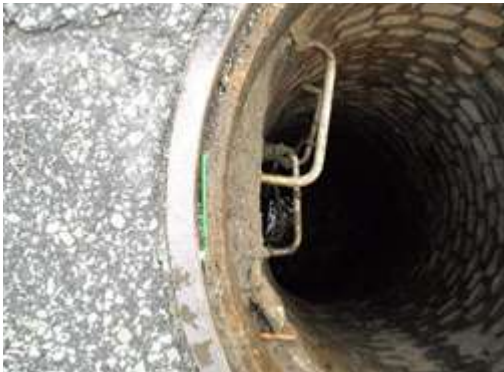
Defect 6

Frame Offset: **0** (in.) Condition: ☐ Sound ☐ Cracked ☒ **Leaks**

FRAME OFFSET 2"

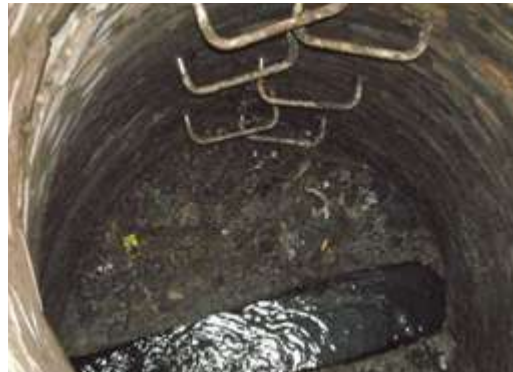
Defect 5

Condition: ☐ Sound ☐ Cracked ☐ Root Intrusion ☐ Deteriorated ☐ Leaks ☒ **Debris**

DEBRIS ON BENCH

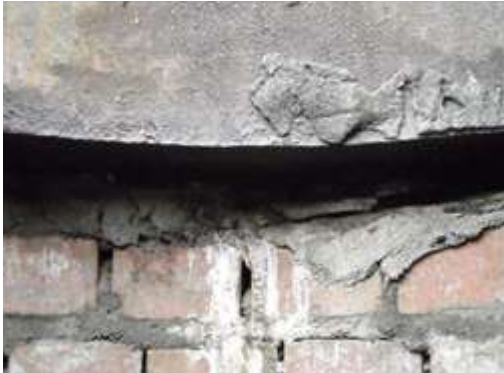
Defect 4

Infiltration: ☐ None ☒ **Joint** ☐ Cracks ☒ **Mortar** ☐ Roots ☒ **Wall**

EVIDENCE OF INFILTRATION BELOW
FRAME AT CORBEL WALL JOINT.
NOTE MISSING BRICKS BELOW

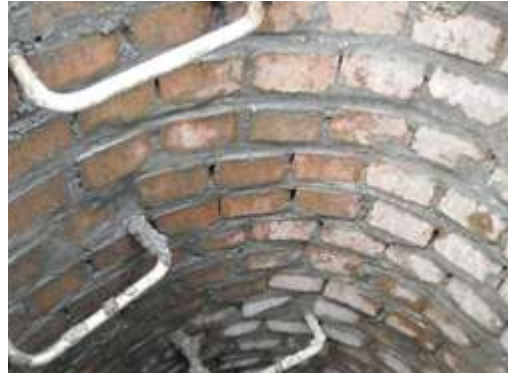
Defect 3

Condition: ☐ Sound ☒ **Cracked** ☐ Root Intrusion ☐ Loose Brick ☒ **Deteriorated**

DETERIORATION OF MORTAR IN
CORBEL WALL

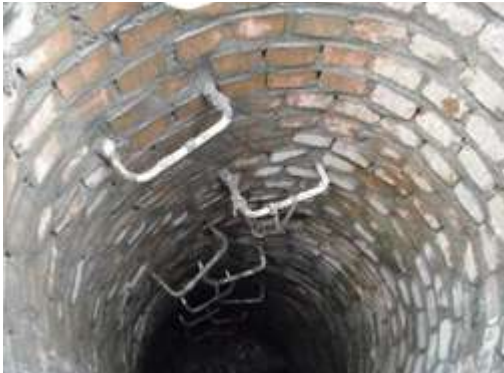
Surcharge ☒ **Evidence Of Surcharge** Depth: **12** (ft.) ☐ Active Surcharge Present

EVIDENCE OF SURCHARGE AT 12
FEET

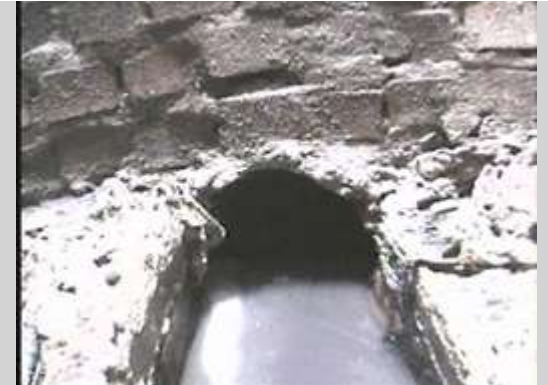
12 O'Clock Outflow

10 in. Circular Gravity Sewer
Pipe Out @ 12 O'Clock

Pipe Height: **9.6** (in.) Rod and Bar (Angled)
Pipe Material: **Clay** ☐ Pipe Lined
Invert Depth: **14.85** (ft.) Flow Characteristics: **Slow**
Deposits: ☐ None ☐ Mud ☐ Sludge ☒ **Debris** ☒ **Grease**
Silt Depth: **3** (in.) Deposits Extent: **Medium**
Infiltration: **None** Pipe Seal Cond: **Sound**

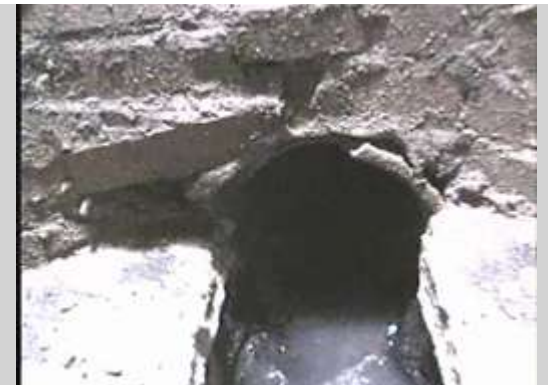
6 O'Clock Inflow

10 in. Circular Gravity Sewer
Pipe In @ 6 O'Clock

Pipe Height: **9.6** (in.) Rod and Bar (Angled)
Pipe Material: **Clay** ☐ Pipe Lined
Invert Depth: **14.59** (ft.) Flow Characteristics: **Slow**
Deposits: ☐ None ☐ Mud ☐ Sludge ☒ **Debris** ☒ **Grease**
Silt Depth: **2** (in.) Deposits Extent: **Light**
Infiltration: **None** Pipe Seal Cond: **Cracked**
